Windsor House Ruins

The Windsor House burned to the ground in 1890 leaving only 23 columns where the mighty house once stood. EMS, Inc was hired to 3D scan the entire site as well 3 columns in very high detail. Once 3D scanned EMS created high resolution renderings of the column site and 3 individual columns. In addition, a scaled 3D printed model was also created. The renderings and 3D printed model are being used to raise funds to create 3 full size columns to be put on display.

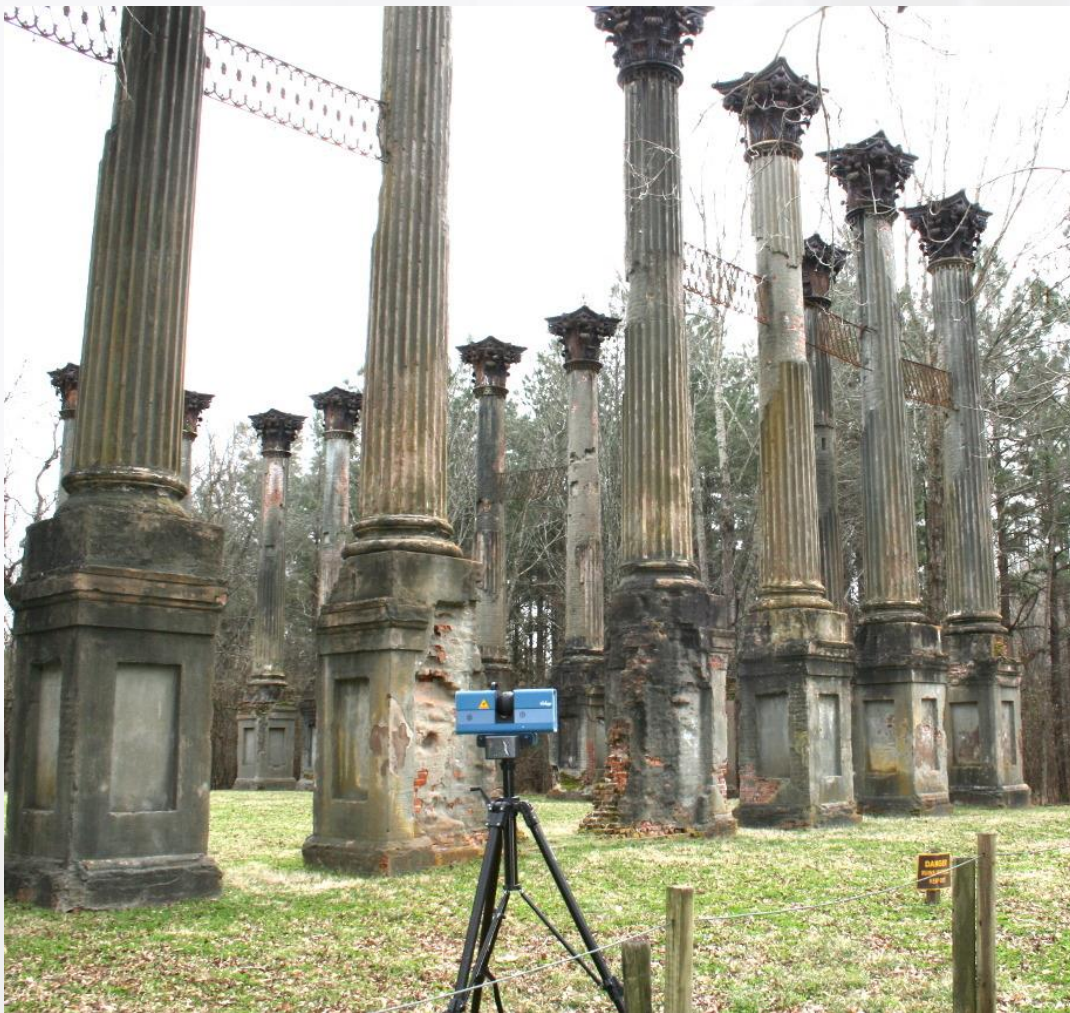
3D Scanning all 23 columns to generate a high resolution rendering and 3D model

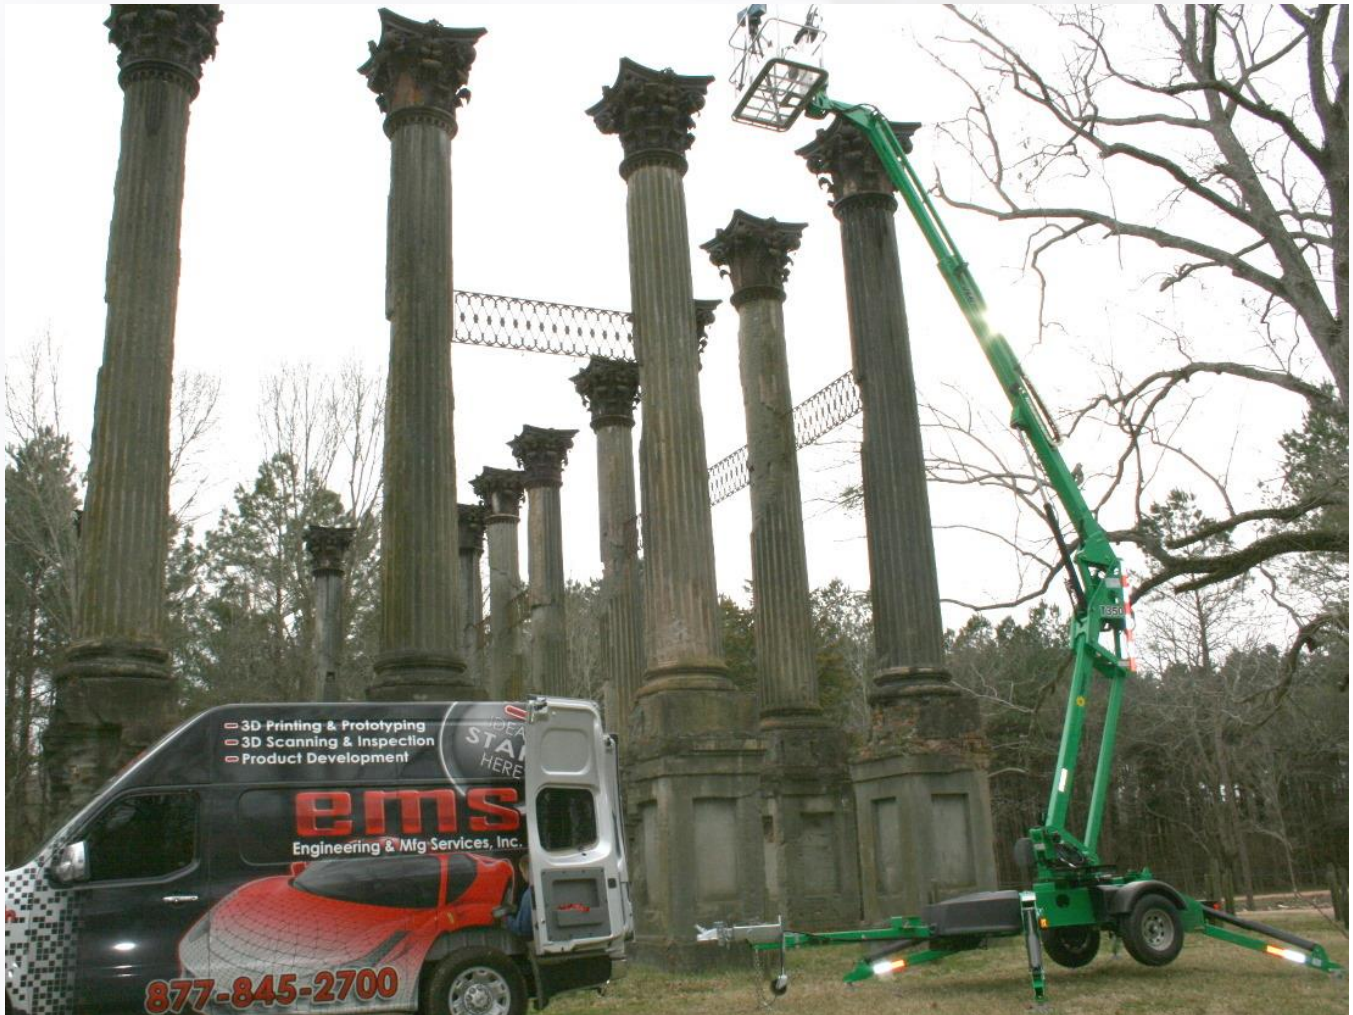
Because the columns are 43 feet tall, EMS used a lift to 3D scan the capital area as they are extremely detailed

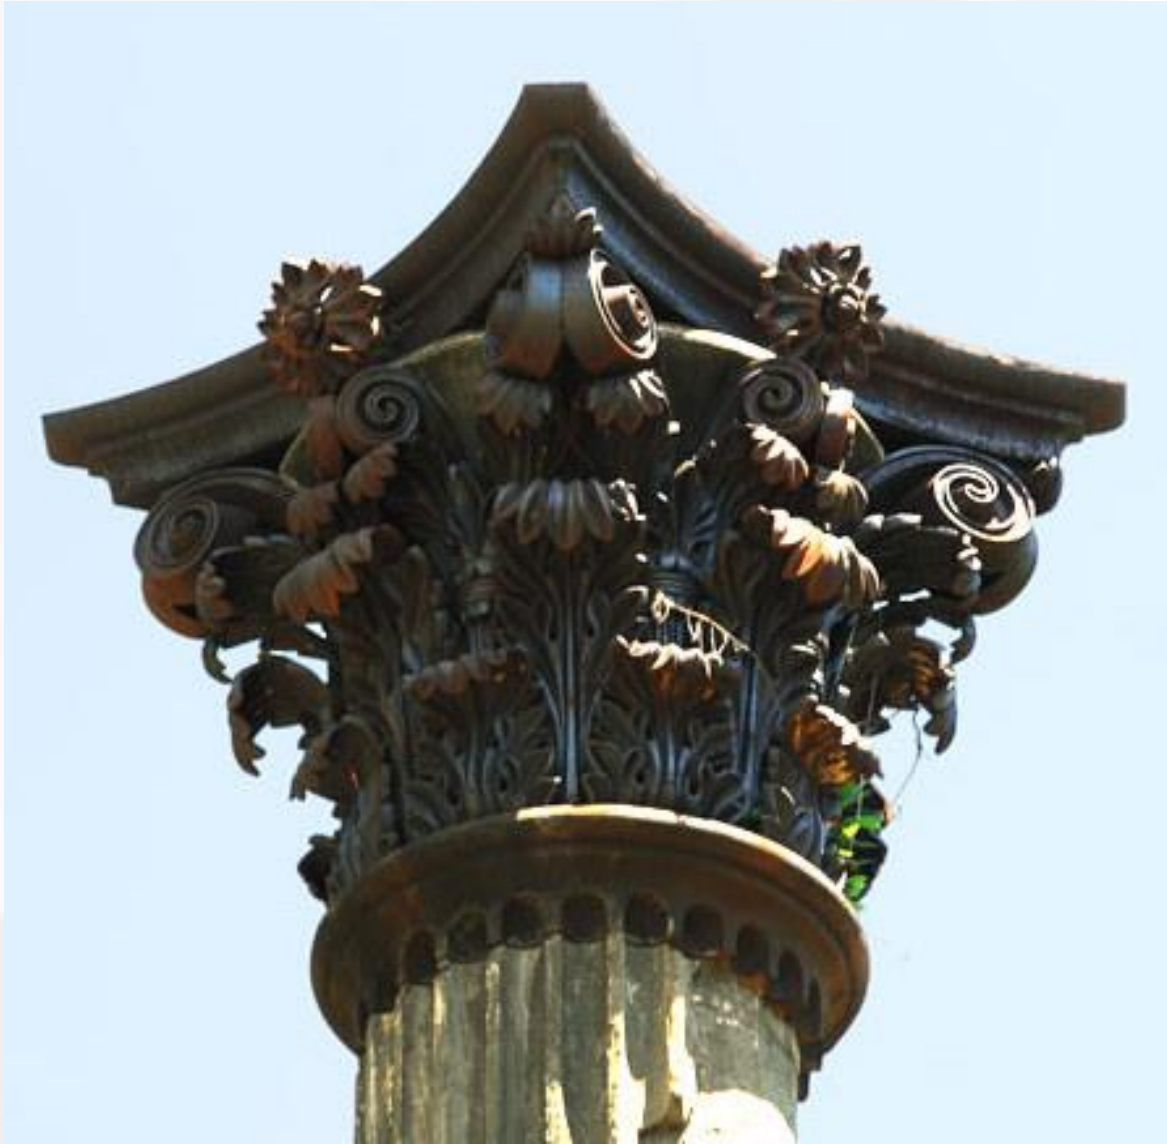
Close up of the column capital. Because of the level of detail the highest resolution 3D scanners were required

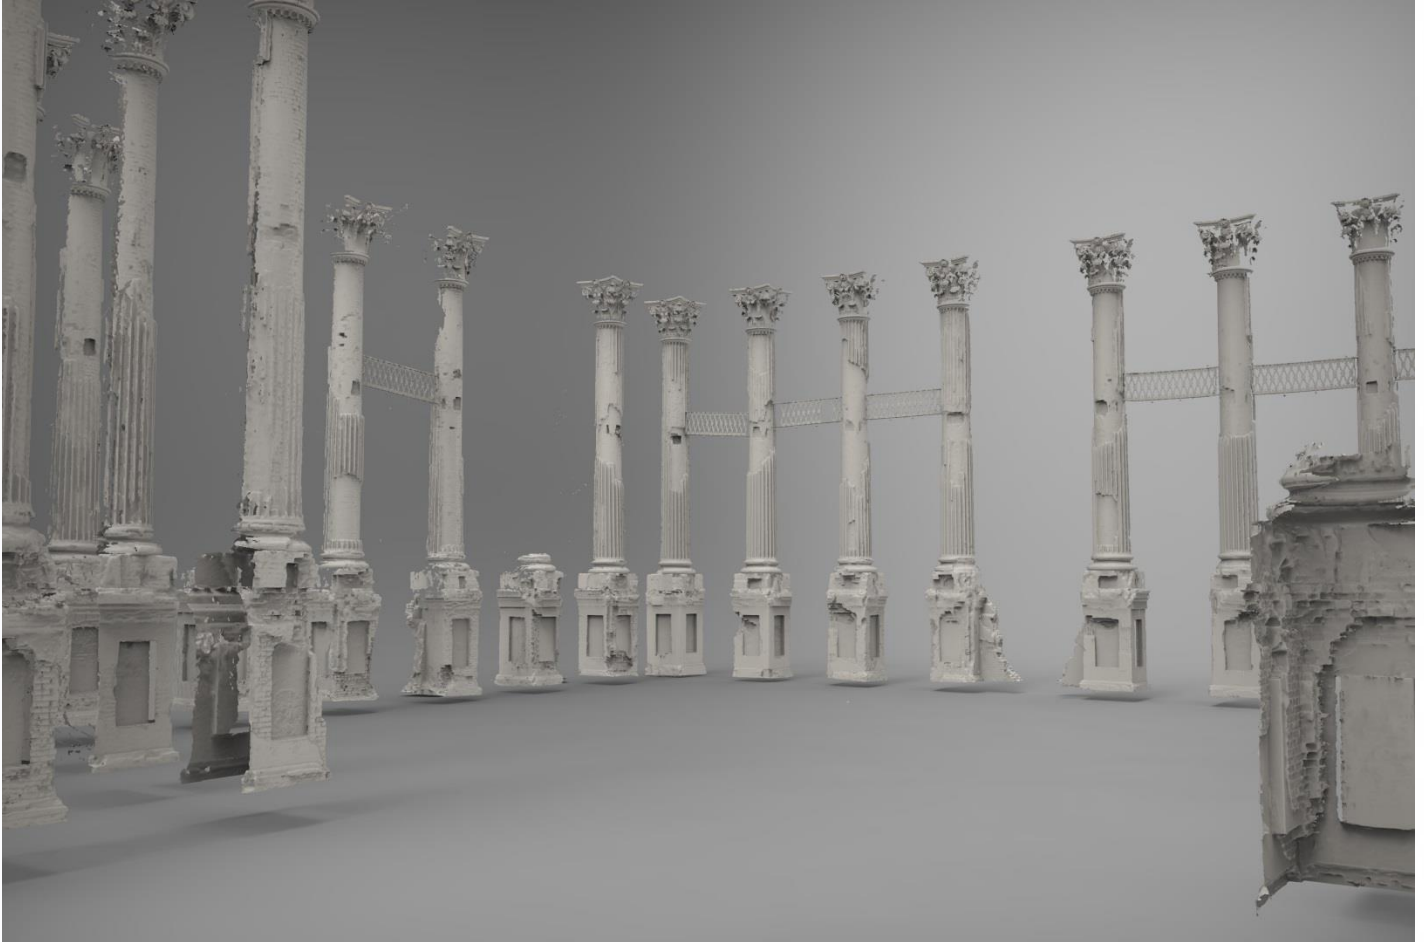
Rendering from the 3D Scan data of entire site to include all 23 columns

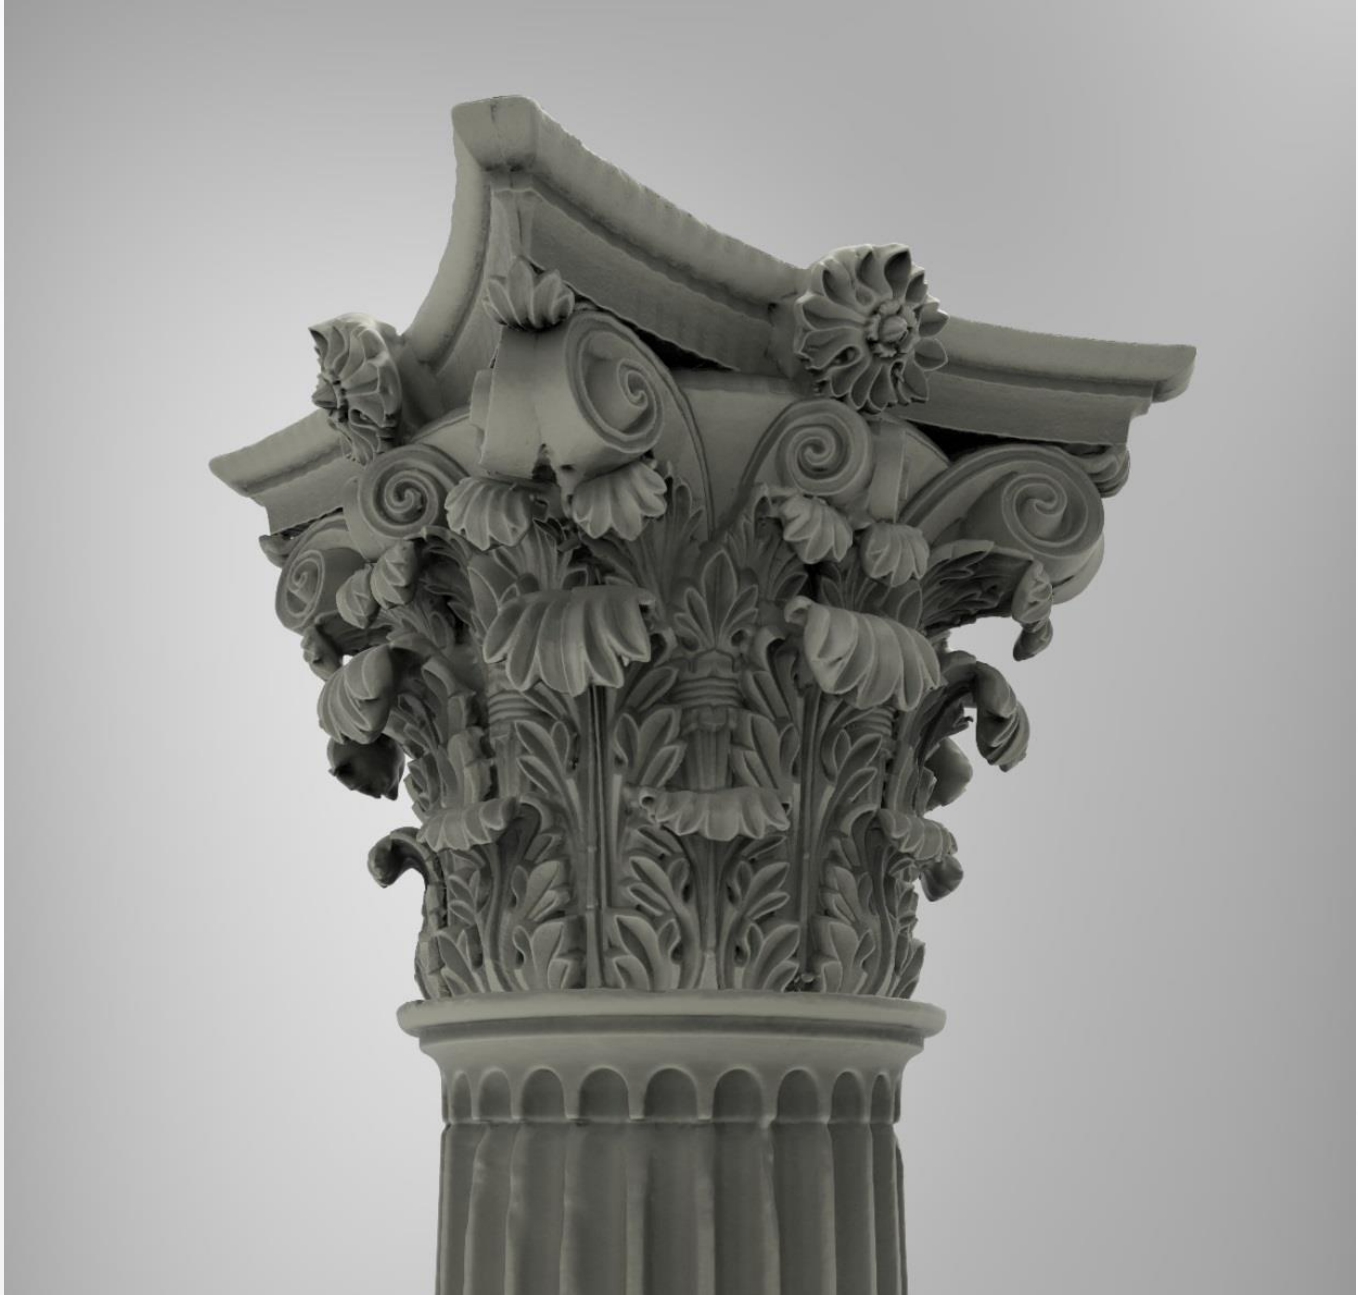
Rendering from the 3D scan data of the capital area.

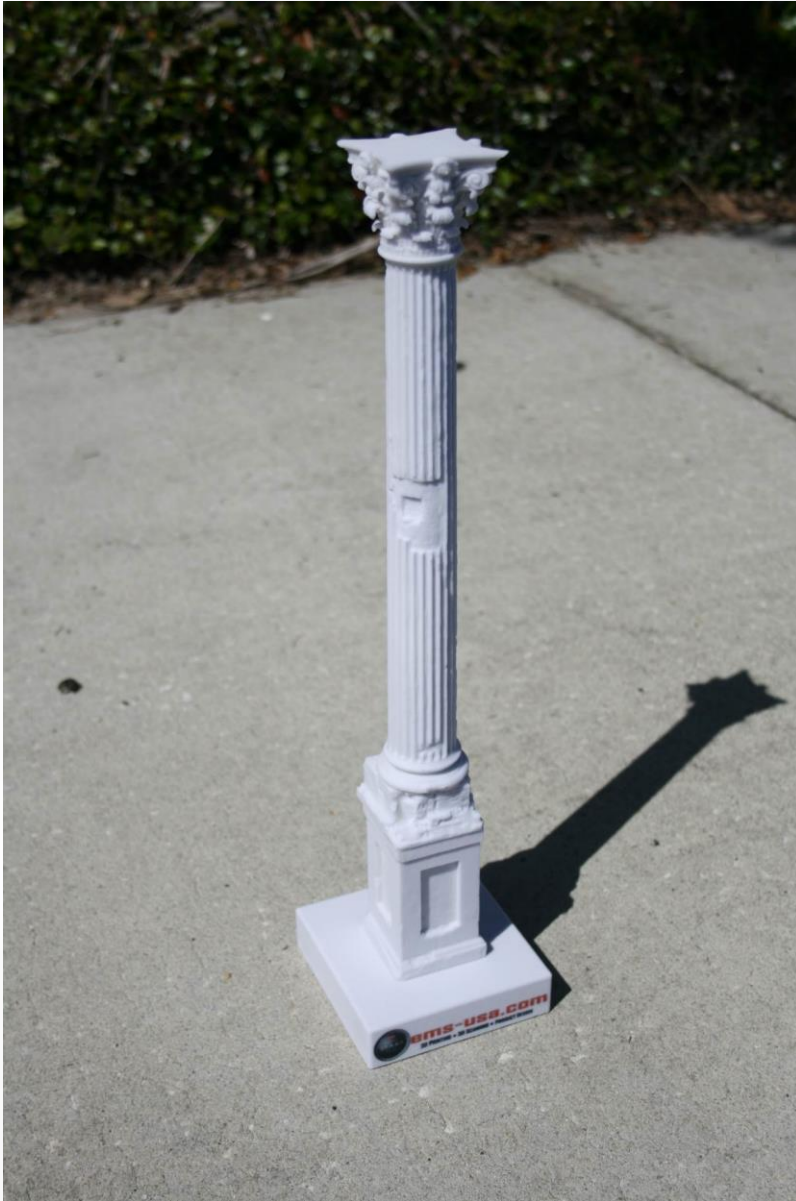
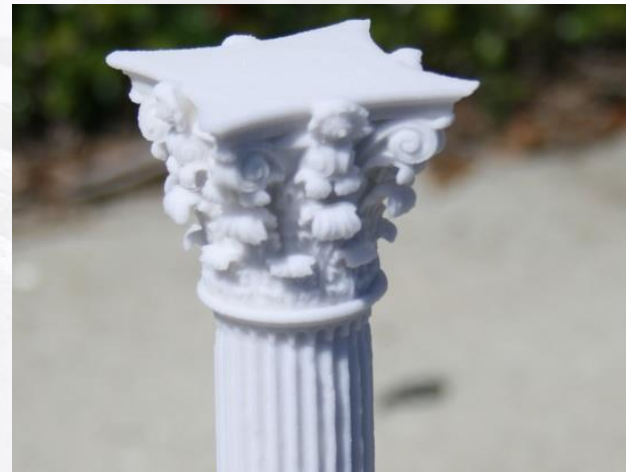
3D Printed scaled model from 3D Scan data
